**Advancement in the Area of Intrinsically
Locatable Plastic Materials**

CAAP Final Report

Date of Report: September 29, 2017

Prepared by: West Virginia University, Constructed Facilities Center (WVU-CFC)

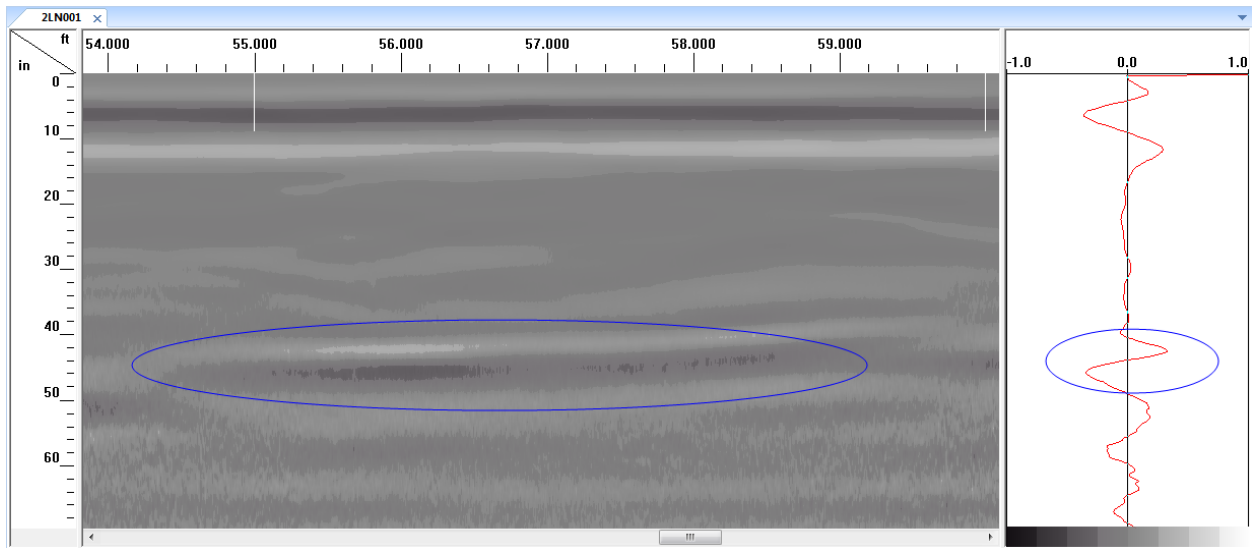
A comparison of GPR signals between the three cases of 6" diameter PVC pipes (unwrapped, and with aluminum foil ring or strip) shown in Figures 4-18, 4-19, and 4-20 indicates that the PVC pipe with the Aluminum Foil Strip on the top is the most prominently detectable configuration as indicated by the high strength of GPR signal in the A-scan in Figure 4-20.

Figure 4-19: Longitudinal GPR scan (left) and A-Scan (right) over Al. Foil Ring 6" PVC pipe

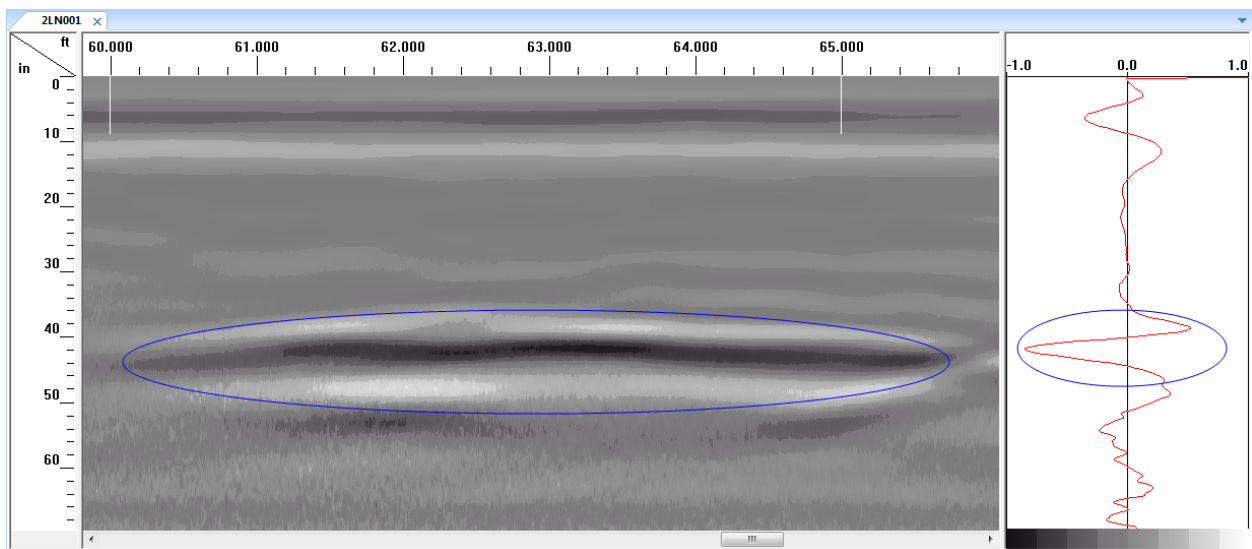
Figure 4-20: Longitudinal GPR scan (left) and A-Scan (right) over Al. Foil Strip 6" PVC pipe

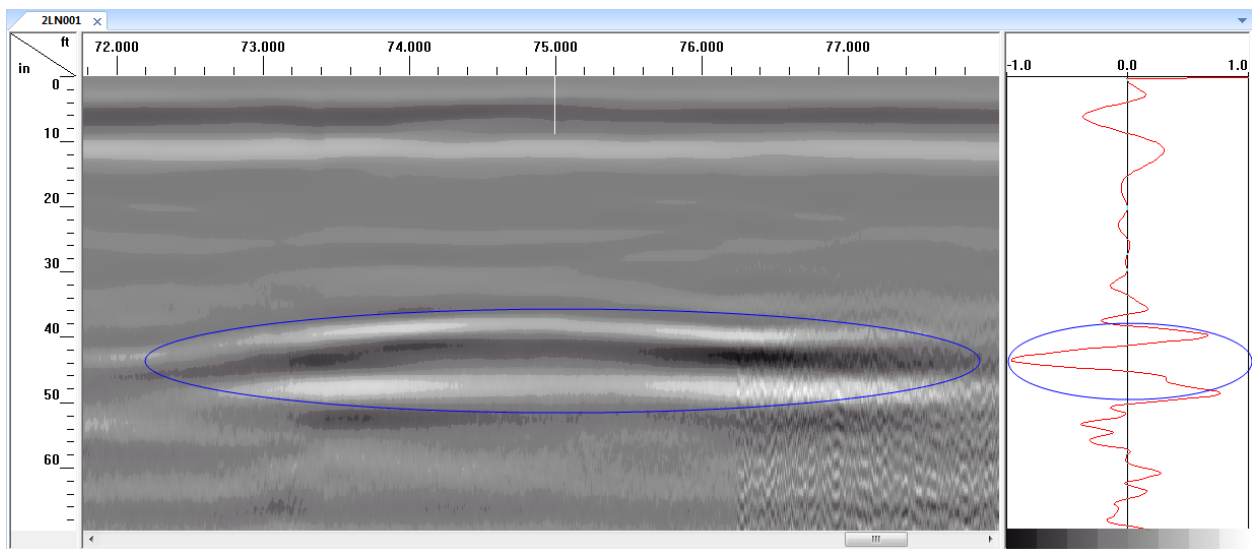
Figure 4-22: Longitudinal GPR scan (left) and A-Scan (right) over CFRP Strip 6" PVC pipe

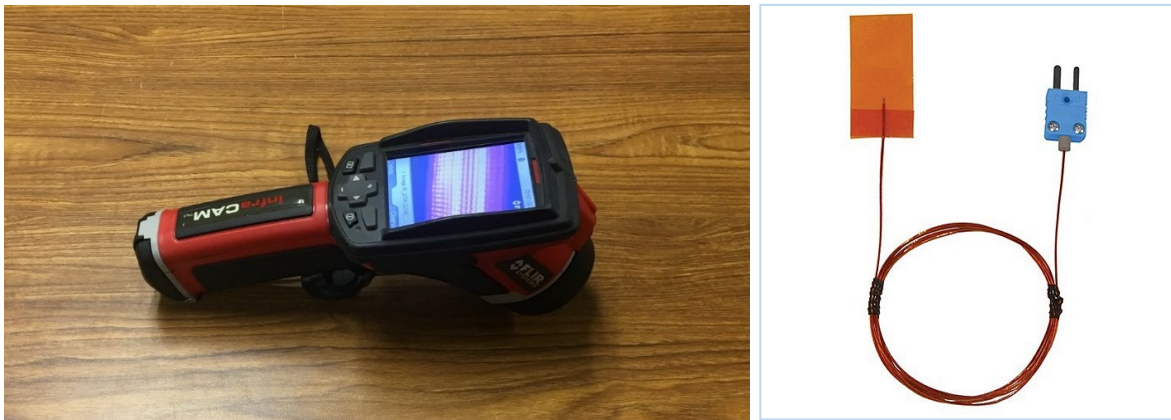
FLIR InfraCAM SD thermal imager (Figure 5-1 (a)) was used for the IRT testing. This is a portable handheld infrared camera with a spectral range of 7.5 to 13 μ m, a 0.12°C thermal sensitivity at 25°C, and \pm 2°C accuracy.

(a) FLIR InfraCAM SD camera

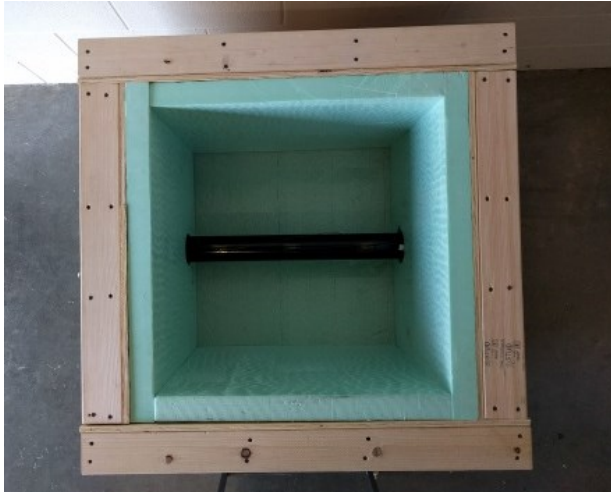
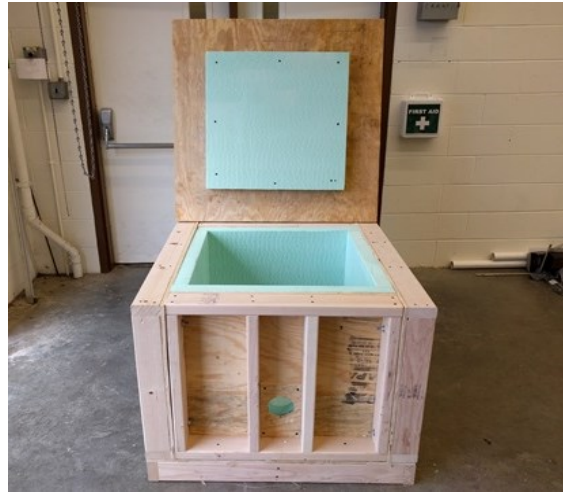
Figure 5-2: Insulated wooden box used for IRT testing

An insulated wooden box with an internal dimension of 24"x24"x22" (after insulation) was built for the IRT testing of buried CFRP pipe carrying hot liquid. The insulation in the box (with R-Value of 10) will ensure that heat detection (if any) will only be as a result of heat propagation from the hot pipe to the soil surface. Also, the insulation ensures no heat leakage out of the box, which will help in heat transfer computations to extrapolate the surface temperature for different soil depths. Figures 5-2 and 5-3 show the wooden box and capped 3" diameter CFRP pipe respectively. The CFRP pipe, fitted with aluminum caps was buried in the insulated box with hot water circulated through the pipe

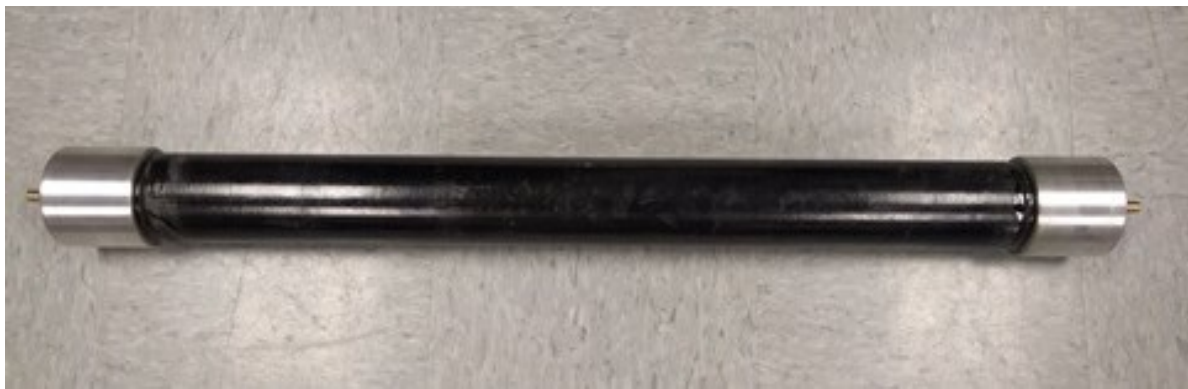
Figure 5-3: Capped CFRP pipe used for IRT testing

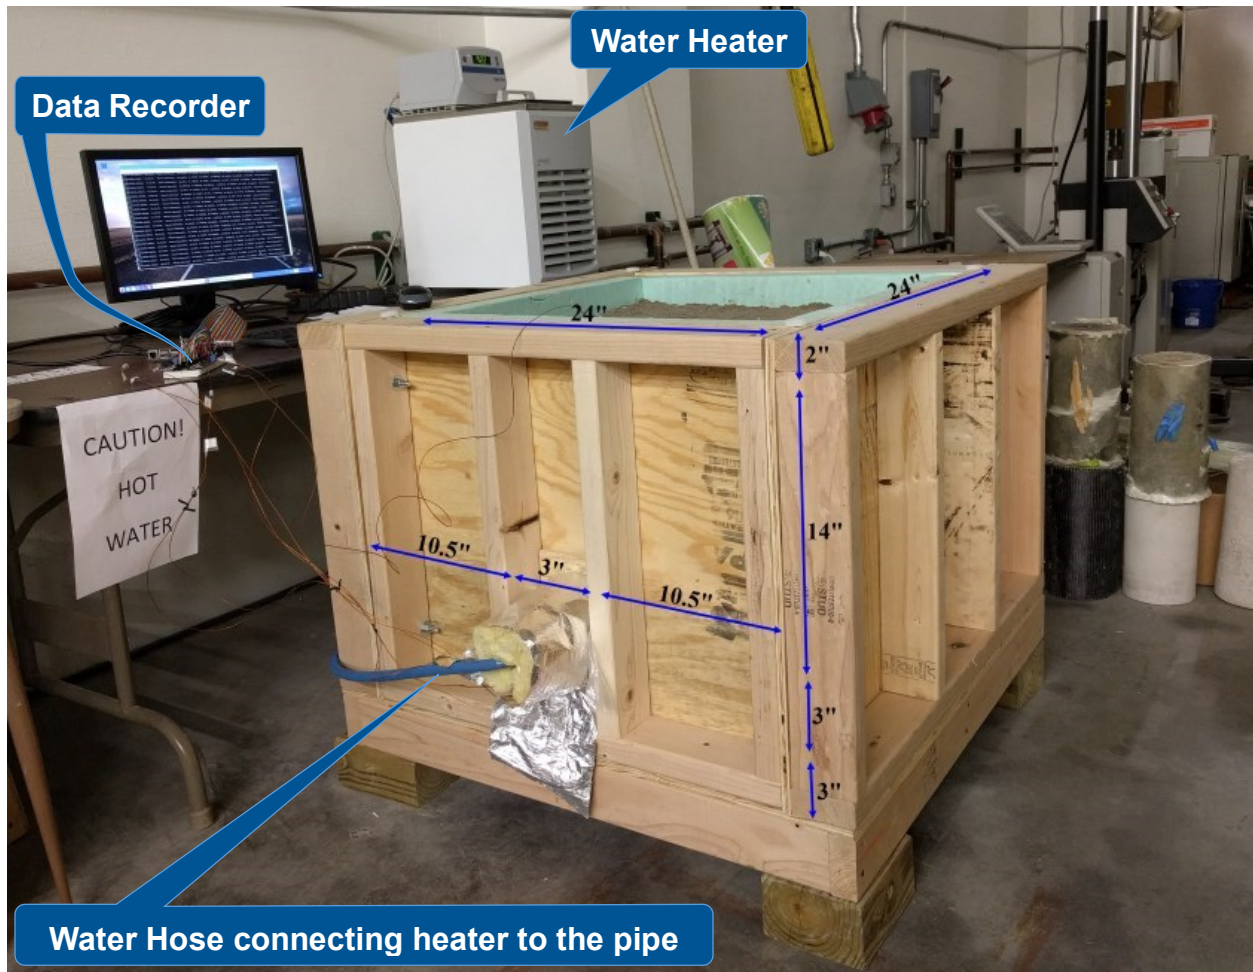
Five thermocouples were installed on the surface of the CFRP pipe before burying (3 thermocouples at the top and 2 at the bottom surface of the pipe). Another thermocouple was placed at the surface of soil in the box to measure soil surface temperature. Hot water (at a temperature of 95°C) was circulated through the buried pipe, while the temperature changes at the surface of the buried pipe and the soil surface were recorded over a period of 10 days. Soil surface temperature was also recorded using infrared thermography (IRT) throughout the testing period. It should be noted that, water circulation was started with the water initially at room temperature (21.6°C), and it took 3 hours for the water temperature to rise to the 95°C level. Also, the hot water did not fully fill the pipe to the top, hence top portion of the pipe was colder than the bottom portion by about 4.5°C because of the trapped air pocket at the top. The IRT test setup is shown in Figures 5-4.

Figure 5-4: IRT test set-up

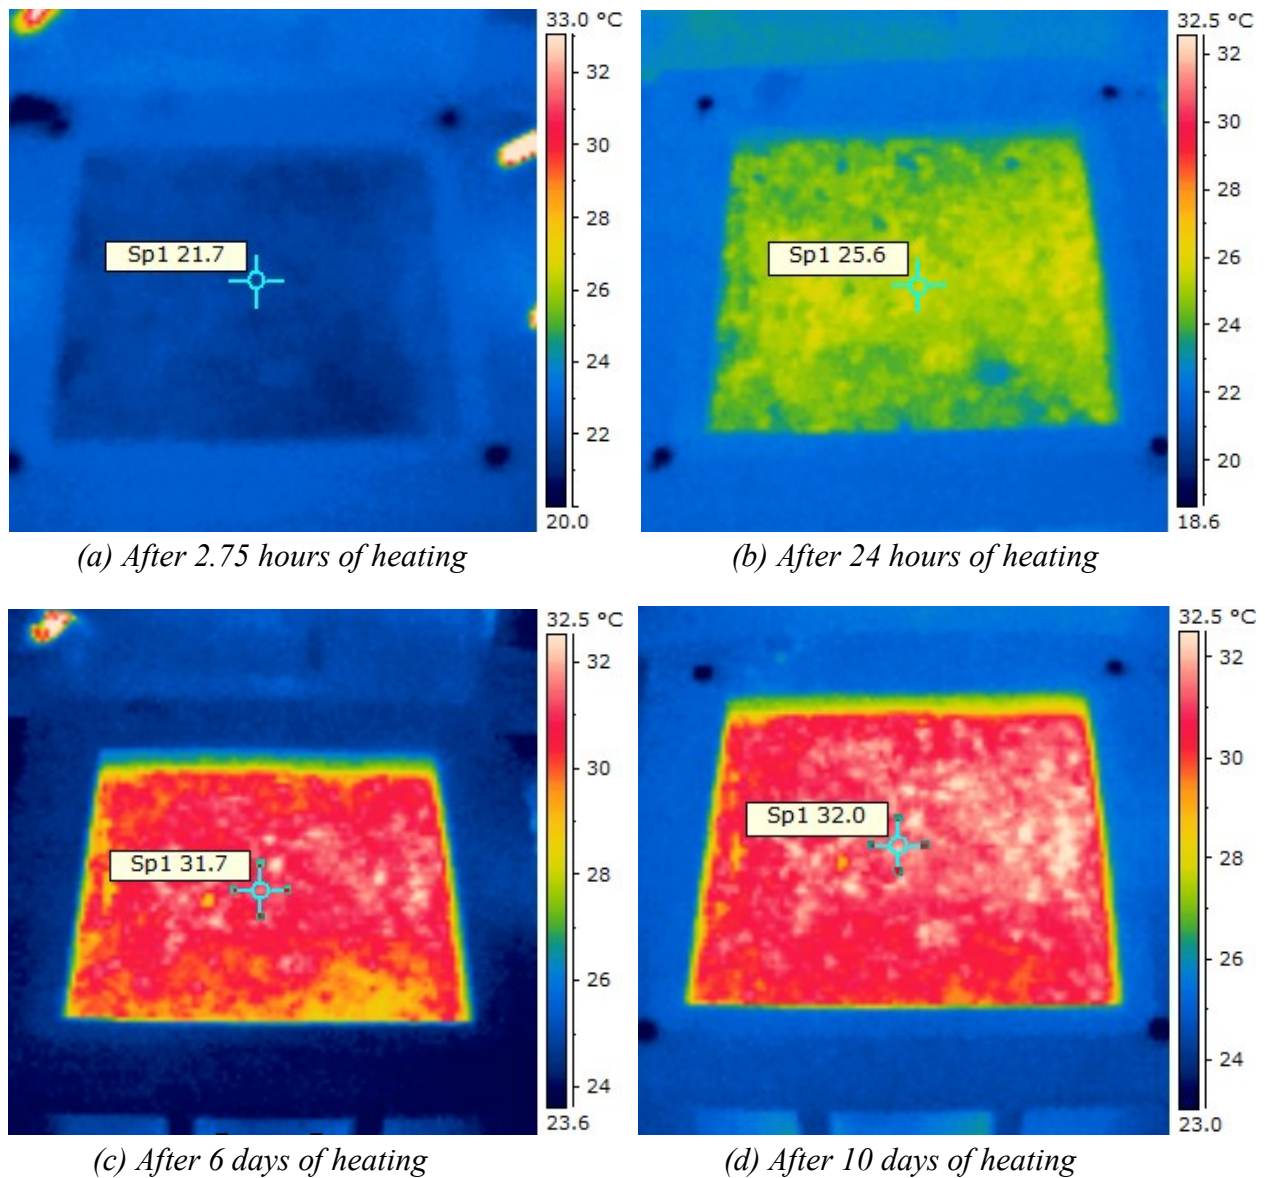
Figure 5-5: Infrared thermography data at the soil surface at various stages of testing

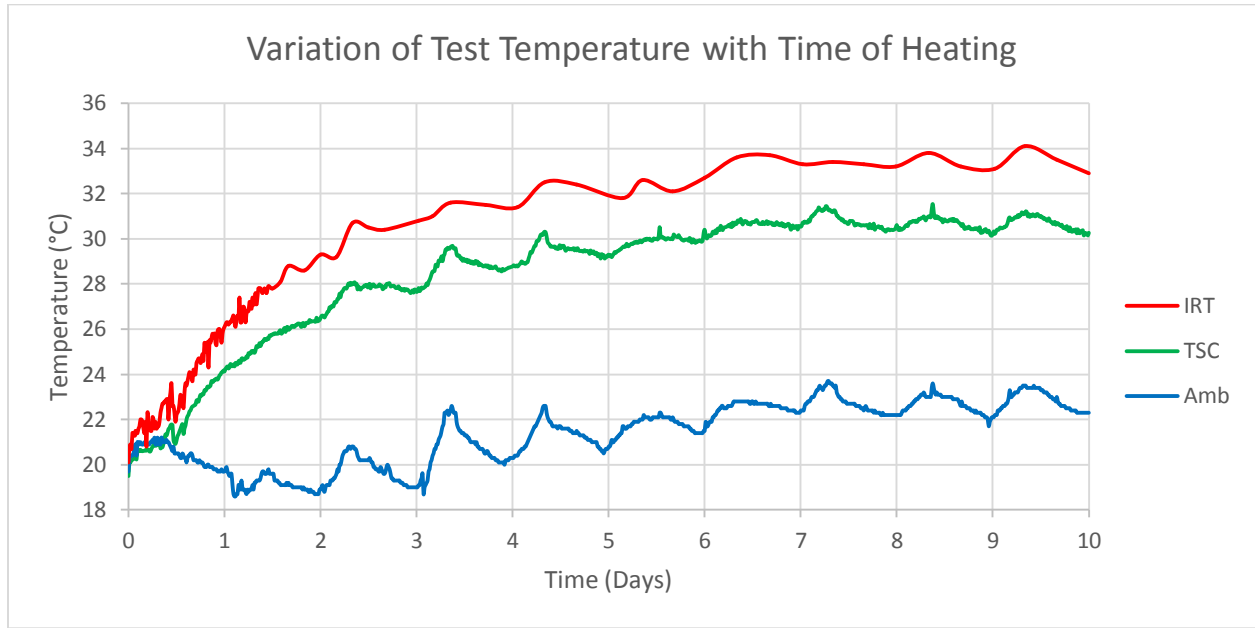
Figure 5-6: Variation of soil surface (TSC, IRT) and room (Amb) temperatures with time

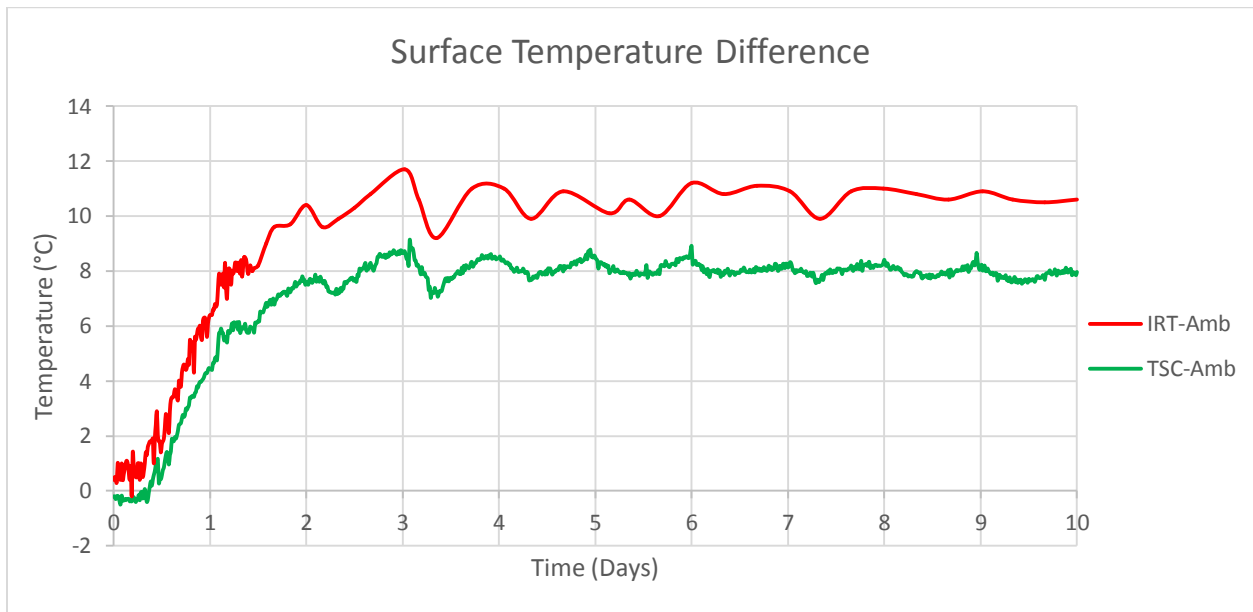
Figure 5-7: Soil surface temperature difference with time

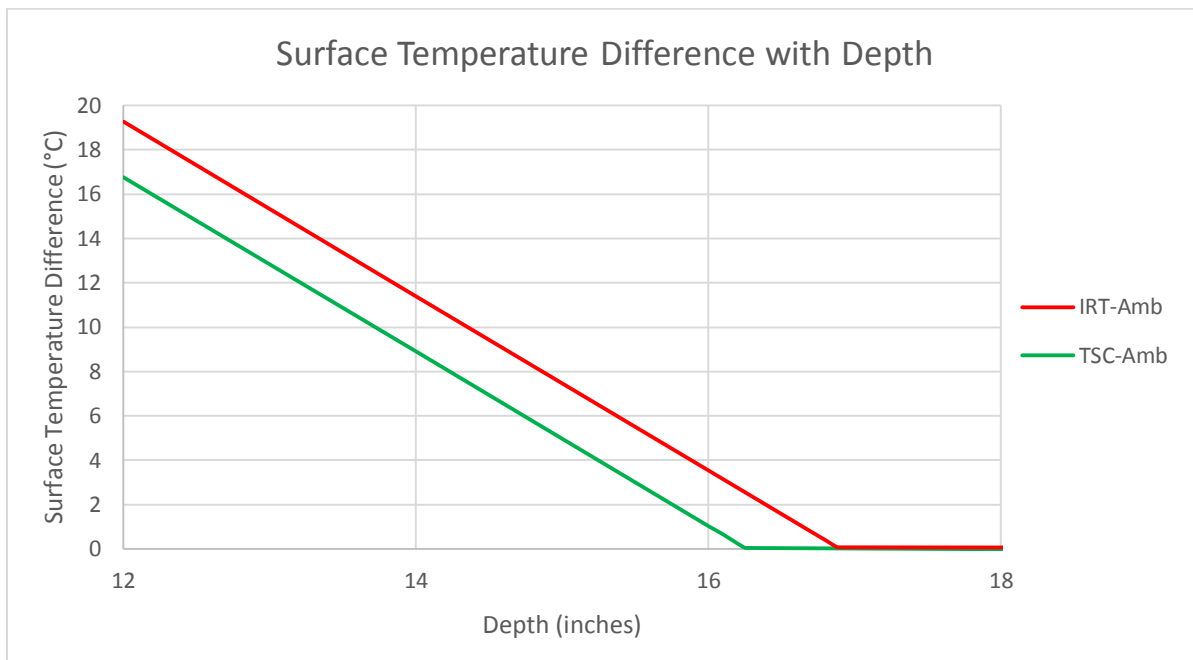
Figure 5-8: Difference between soil surface temperature and room temperature with depth

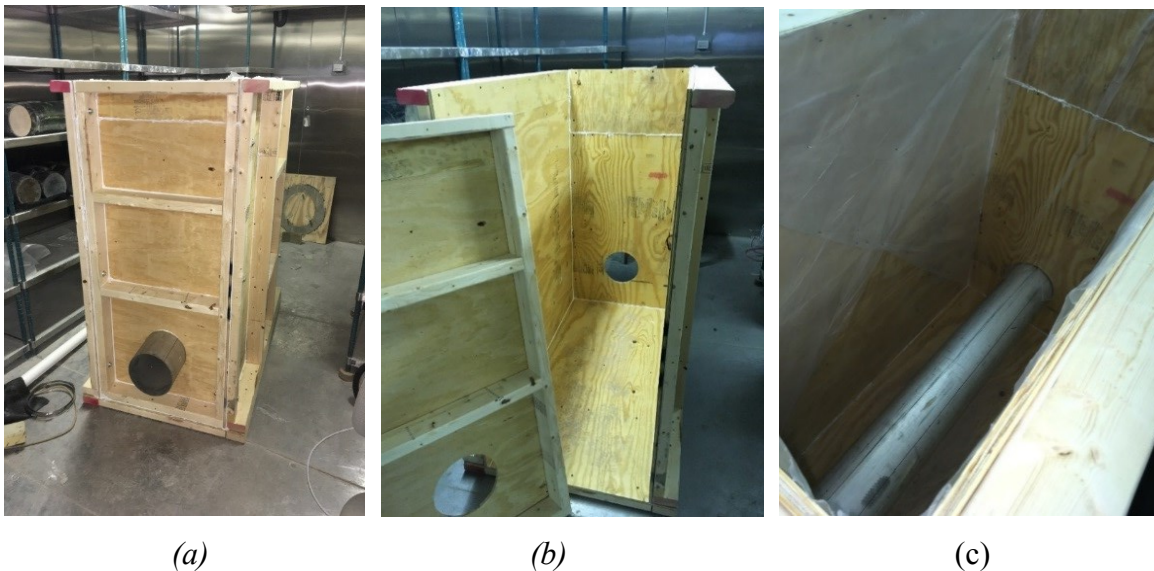
Initially it was decided to simulate a leaking buried pipe by constructing a wooden box into which a pipe of up to six inches in diameter could be inserted. The box was then filled with crushed stone and dirt to bury the pipe. The pipe had a tiny hole drilled in its wall to simulate a gas leak underground. The first wooden box which was constructed for gas leak detection was filled with highly saturated clay that was not porous once it dried, preventing the gas from flowing through the clay and out of the top of the box. But rather than dig all the non-porous soil out of the old box, it was decided to build a new wooden box for conducting additional experiments. This new box, shown in Figures 6-1 (a), 6-1 (b), and 6-1 (c), was constructed with several improvements over the previous box. All of the seams were sealed with a silicone caulking, the inside of the box was lined with a three millimeter plastic lining and the soil being placed in the box was hand-mixed with sand, gravel, and top soil at a ratio of 1:1:2 respectively. A new eight-inch diameter aluminum pipe

was placed near the bottom of the box to allow for easy insertion and removal of test pipes, and reducing “Fernco” fittings are being used to create a better seal between the aluminum pipe and the test pipe. Overall, the new box will provide a better representation of gas flow through a porous medium, and therefore be a better mimic of an underground pipe leak. The box is currently half full with the hand mixed soil, and tests are being run to ensure that carbon dioxide, the gas used for the leak detection, is leaking through PVC test pipe and the soil, and being detected by the mass spectrometer (see description below) attached to the top of the box.

Figure 6-1: (a) New wooden box, showing caulked seams, (b) Interior of assembled box, and (c) Exterior of assembled box

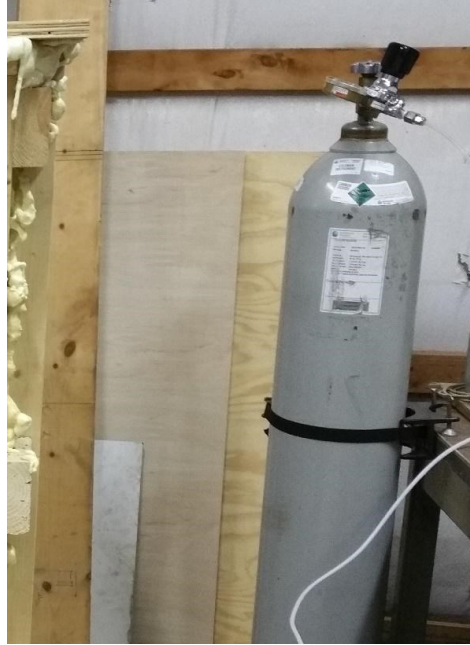
Figure 6-2: *CO₂ Cylinder and Pressure Regulator*

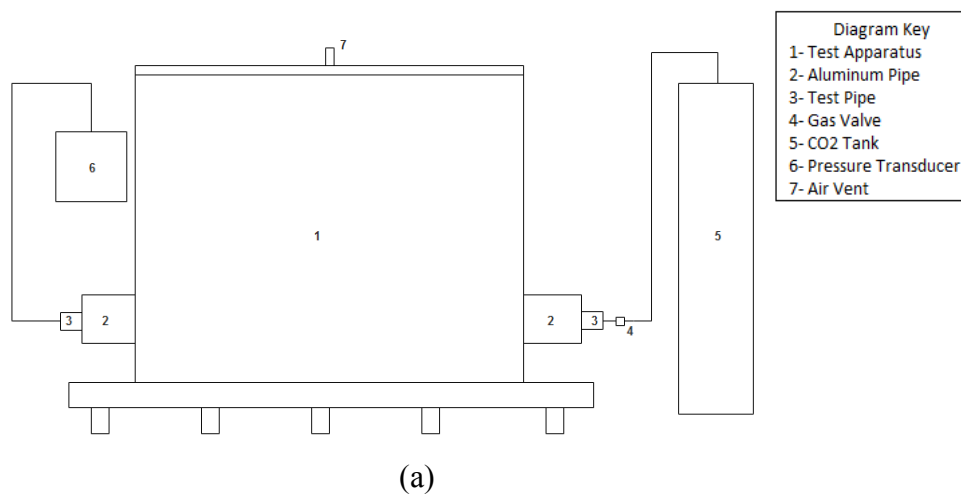
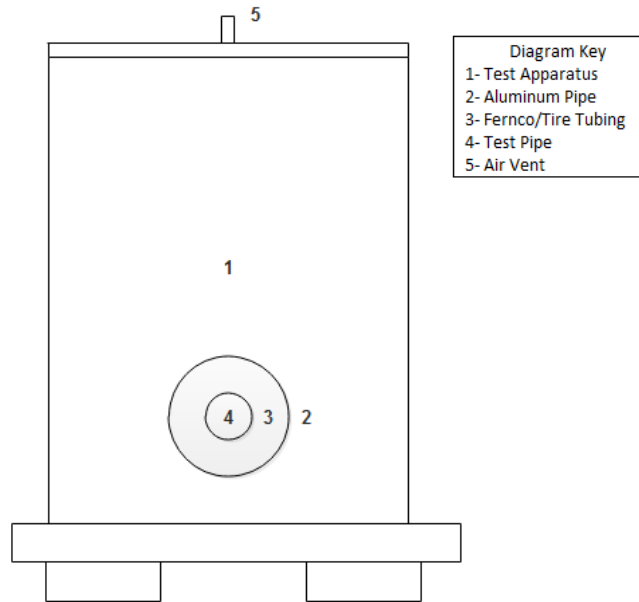
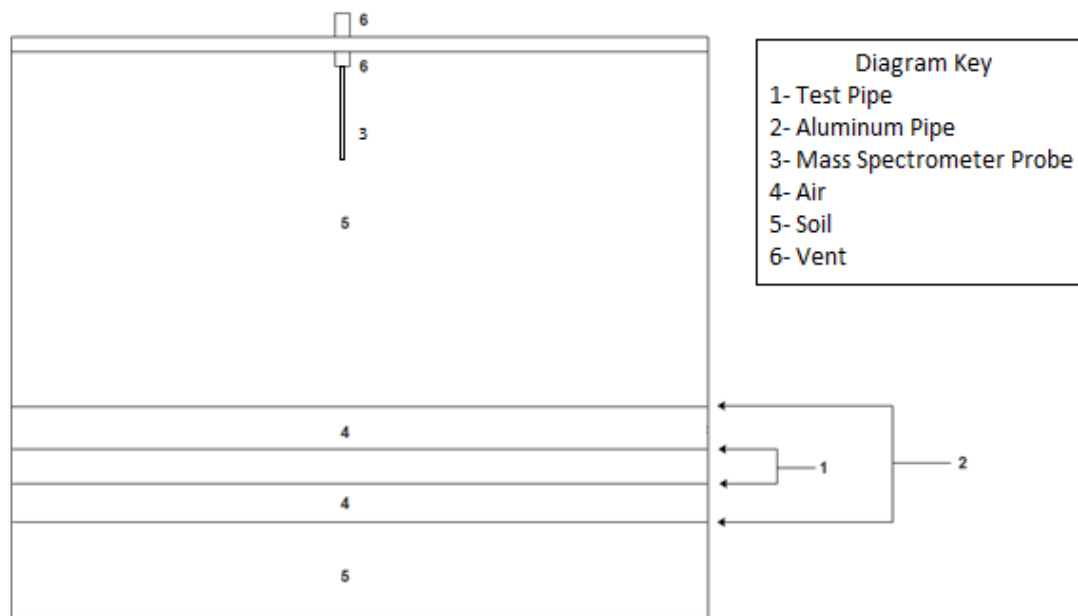
A hole with a diameter of 0.0135 inch (No. 80 drill bit) was drilled into the mid-point of the length of PVC pipe to allow for the simulation of a gas leak in the system. Figures 6-3 (a), (b), and (c) display more detailed schematics of the testing apparatus.

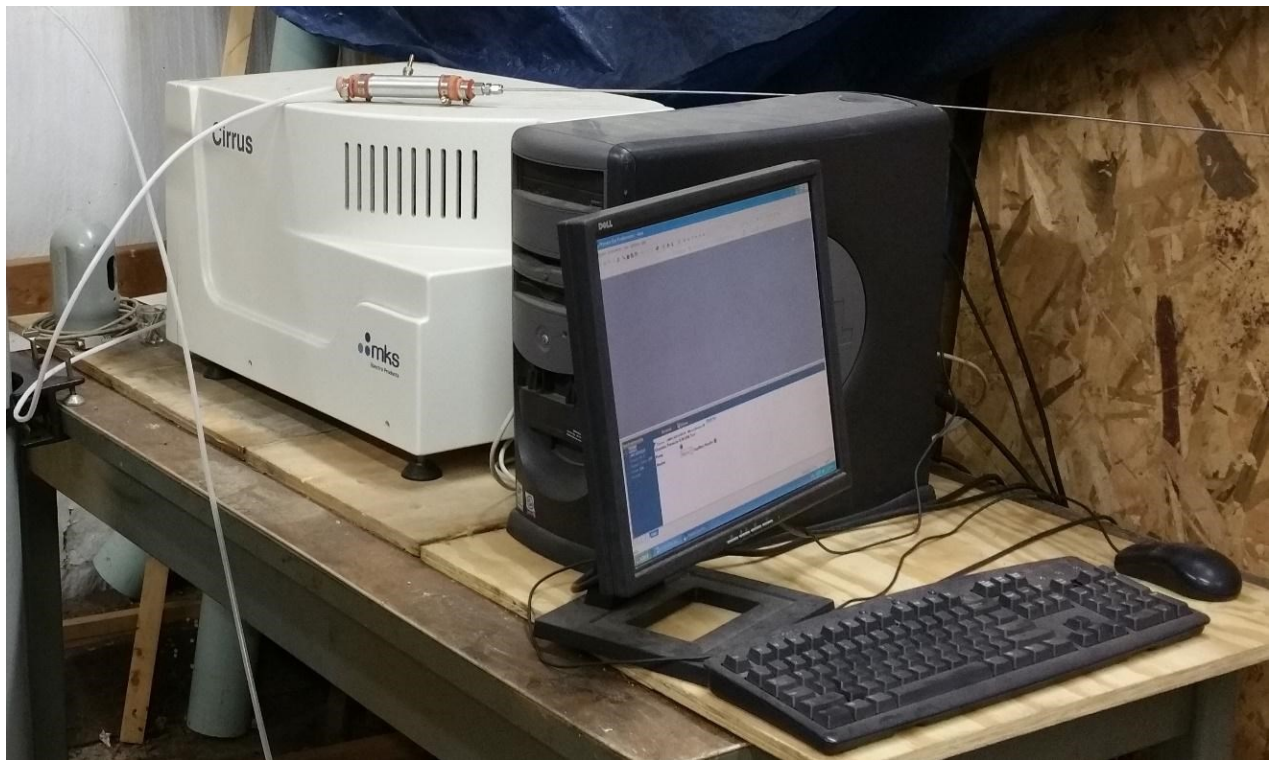
Figure 6-4: Mass spectrometer and associated experimental equipment.

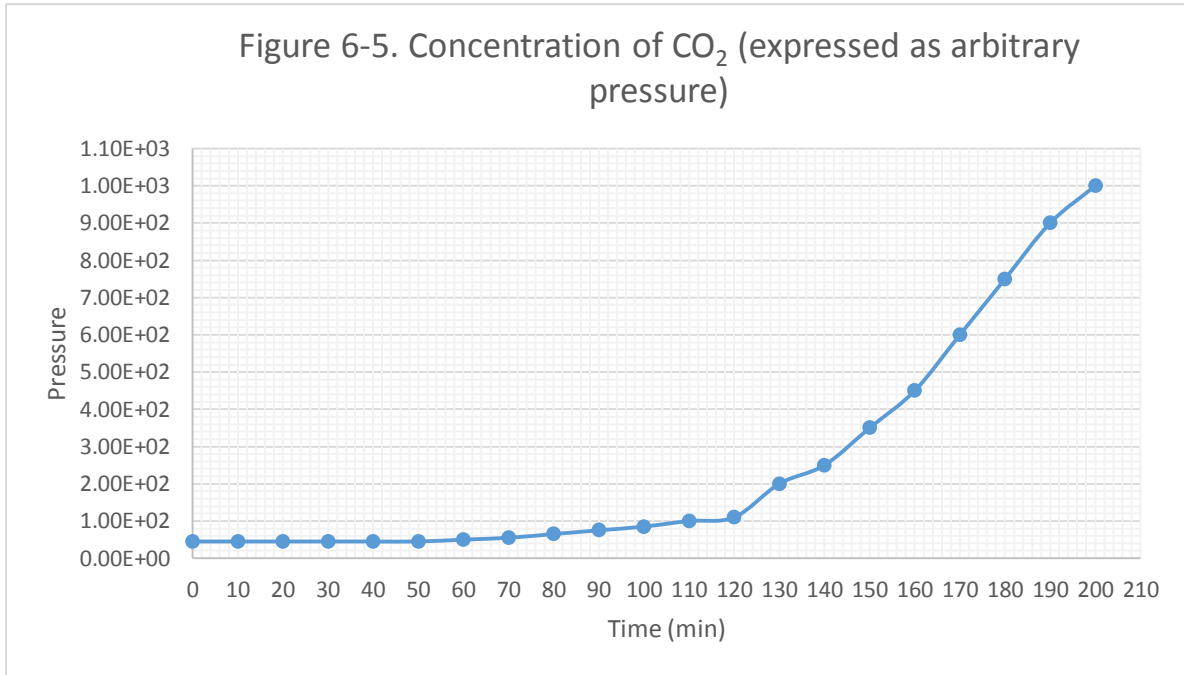
Figure 6-5: Concentration of CO₂ as a function of time for a leak in the test pipe (expressed as arbitrary pressure)
